TR-2363-SHR

EVALUATION OF A CORROSION CONTROL MATERIAL FOR ASPHALT PRESERVATION OF DOD AIRFIELD PAVEMENTS

Prepared by
G.D. Cline

May 2011

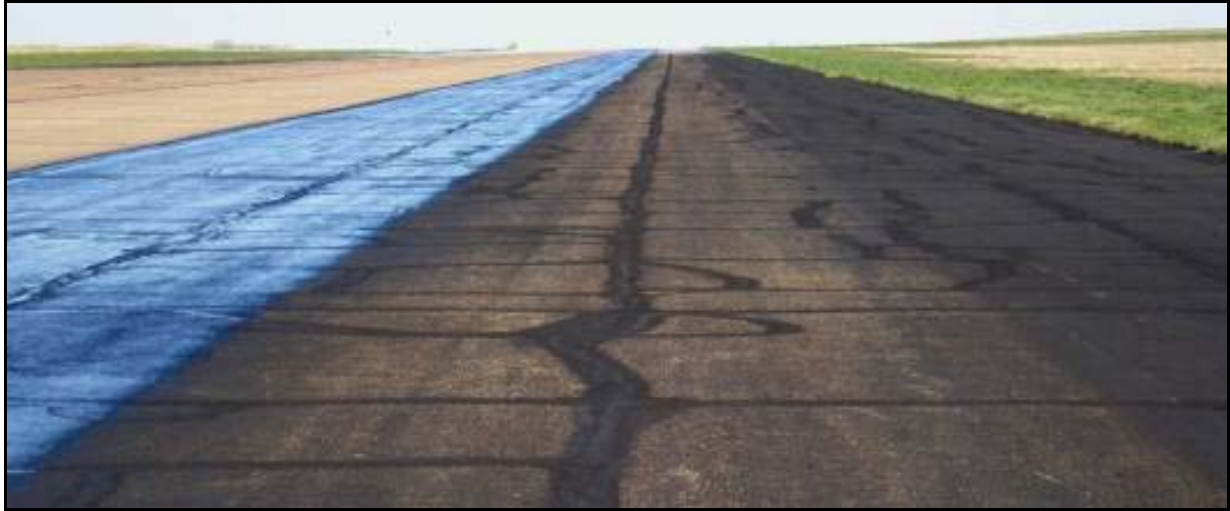
Observations at the time of the site visit demonstrated significant differences between the benefits of GSB and standard asphalt, coal tar emulsions, and rejuvenators. Areas treated with materials other than GSB showed greater severity of distress. Many of the earlier applications were retreated with GSB. The pavement at the Boeing facility was badly aged and undoubtedly would have been unusable by now had it not been for the aggressive preservation measures on Boeing's part. This was the first opportunity to consider the possibility that GSB-88 may rebind deteriorating pavements.

Figure 2. Boeing's 3-year cycle showing (left to right) application in 2006, 2004, and 2005.

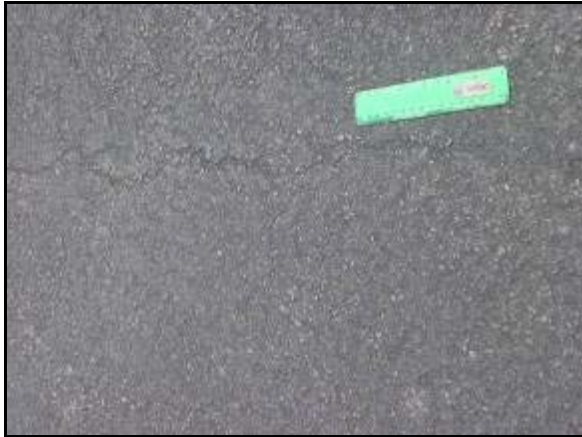
Figure 12. GSB-78 has kept cracks sealed.

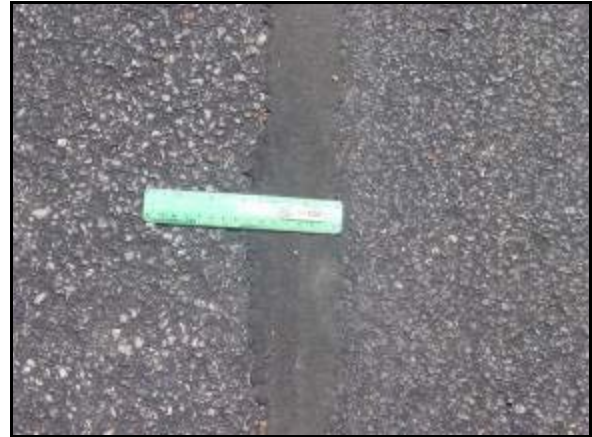
Figure 13. GSB-78 protects the “matrix.”

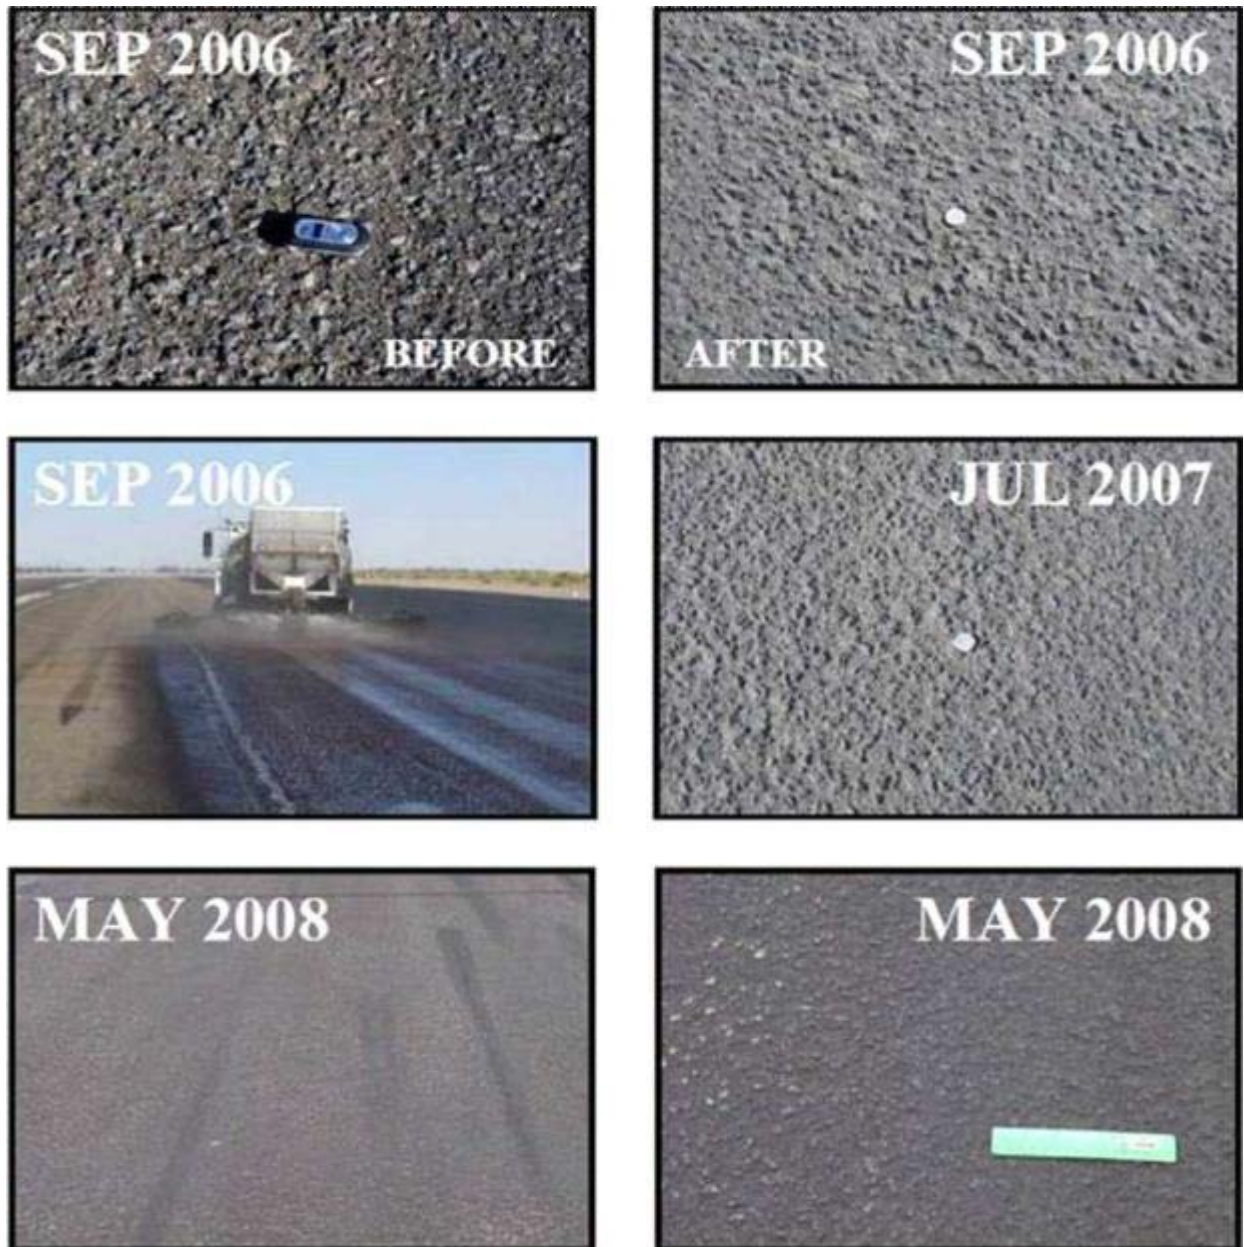
Figure 31. Runway 31L/13R, NAS Fallon, NV.

Runway 31L/13R was prematurely deteriorating due to binder failure and attempts to mitigate the issue using generic fog seal applications had short term results as anticipated [Ref. 29]. However, areas with low to medium severity weathering/raveling distress, where seal coats would not be effective, were to be repaired (patched). Efforts to resolve global corrosion of the

surface by applying typical fog seal coat material with normal procedures, and not repairing localized areas, resulted in high severity weathering/raveling. Although the rate of deterioration for the remaining pavement surface was slightly reduced, deterioration continued at a rate with and anticipated pavement life of about 9 years, which was the average life of pavement at Fallon. It should be noted that pavement life averaged 9 years since initially constructed in 1953 due to the severe vulnerability to thermal cracking in the area where Fallon is located. Although thermal cracking cannot be stopped, the rapid aging that results from open cracks and surface weathering can be significantly reduced, thereby extending the life of pavement if early preventative measures are taken. Critical operations and increasing concerns with FOD resulted in a sudden request for emergency repair and funding. The Project Engineer directed the application of GSB-88, at a significantly 'heavy' rate of application (0.22 gal square yard of 2:1 dilute). Although this action was not in accordance with normal protocol this engineer, based on previous professional experience and an observed understanding of other similarly resolved circumstances, felt confident GSB-88 would at least safely benefit the critical circumstances at NAS Fallon. GSB-88 may be able to inexpensively rebind the pavement and keep the runway in a state of readiness until a more permanent properly engineered and budgeted solution could be accomplished rather than proceeding with the significantly more expensive proposal.

The recommended GSB-88 application proved to be extremely successful in mitigating the problem allowing normal timing for engineering and funding, saving the Navy emergency funding (in this case around \$30M). Based on observed pavement condition with the facilities' pavement engineer at 18 months, two months prior to overlay, the GSB-88 application appeared to be able to continue to maintain the readiness of the runway for some time into the future (see 3.1.7.1 Raveling).

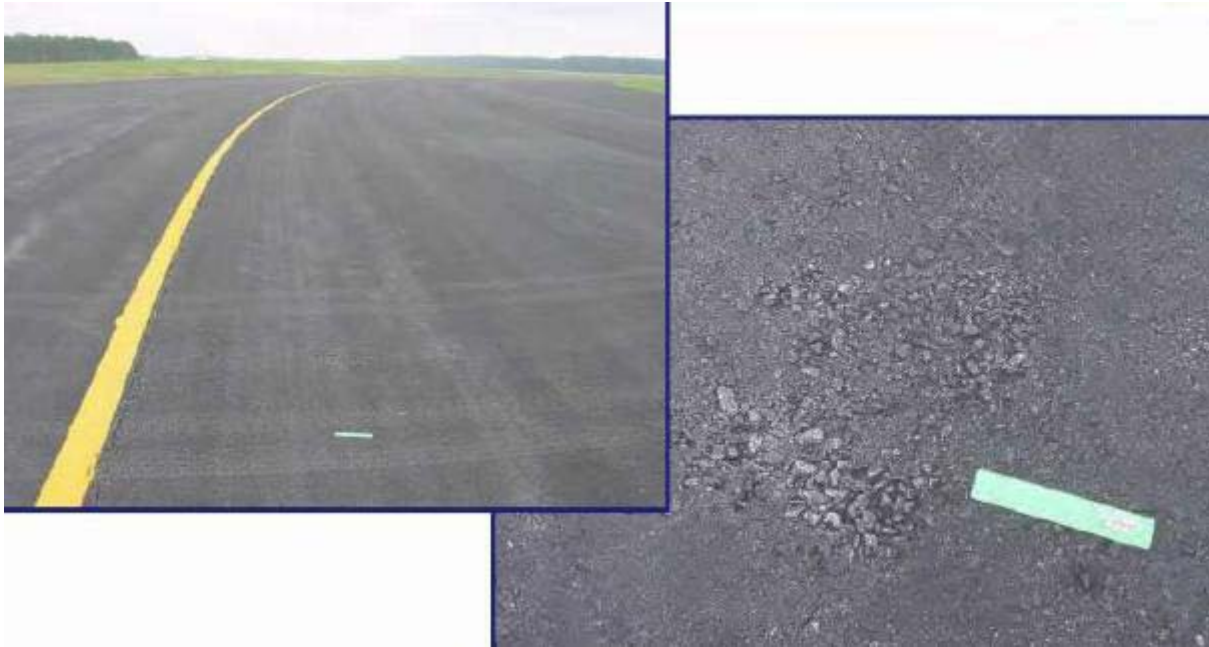
Figure 33. GSB-88 applied to segregated area, resulting in control of pre-raveling.

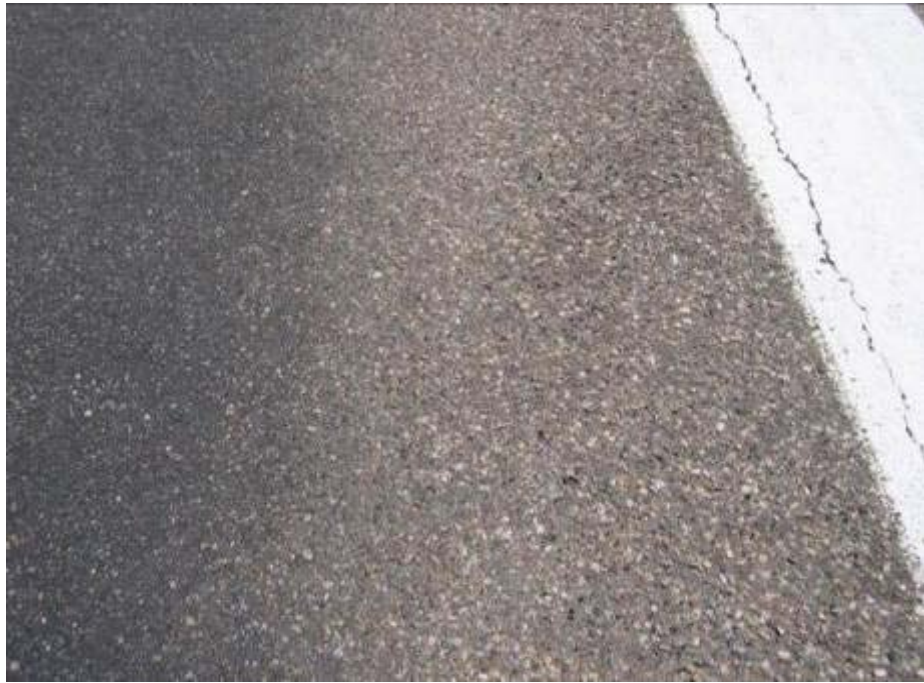
areas of pavement contained FOD on the runway in the untreated areas, but no FOD was found in the areas treated with GSB-88.

Figure 36. Pavement generated FOD on non-treated pavement.

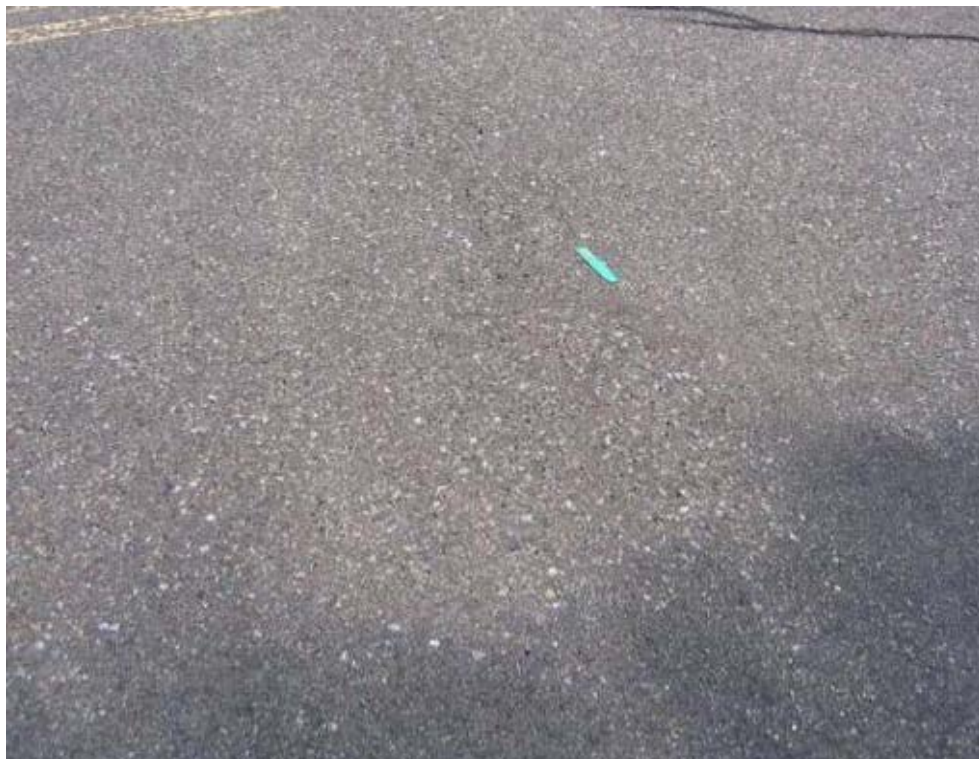
Figure 37. Pavement generated FOD on non-treated pavement.

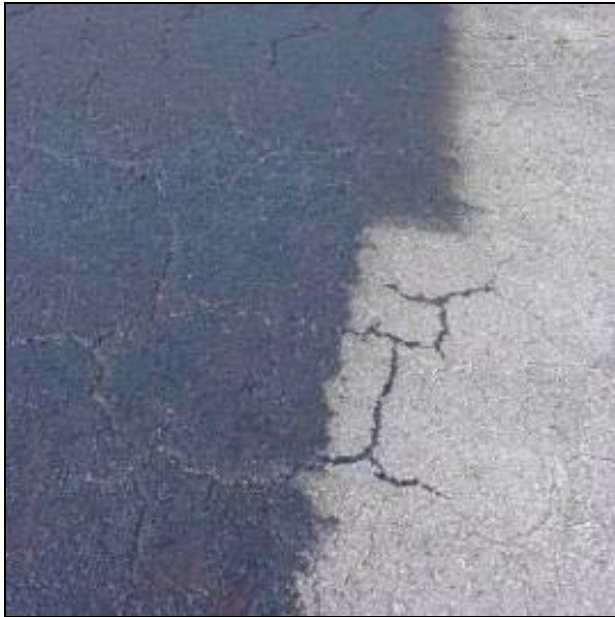
Figure 38. Cracks filling at edge of application.

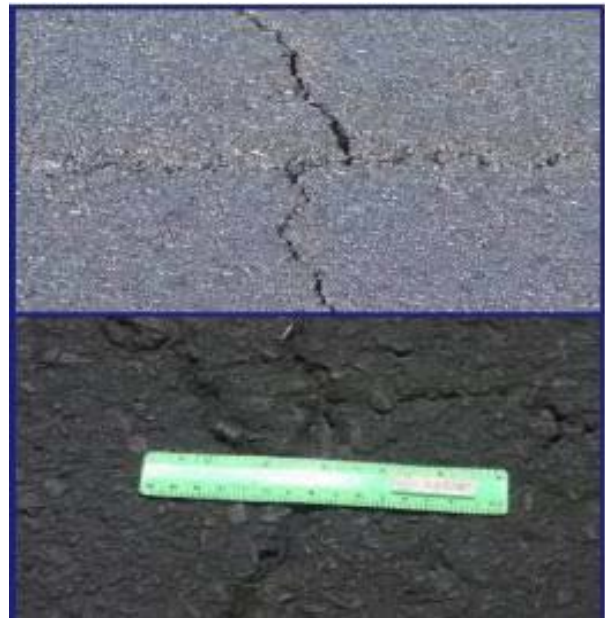
Figure 39. Partial filling with one coat.

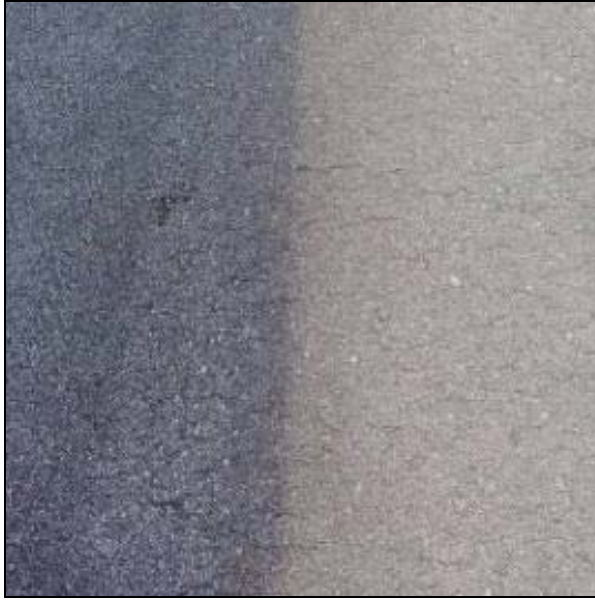
Figure 40. GSB-88 seals ‘checking’ cracks.

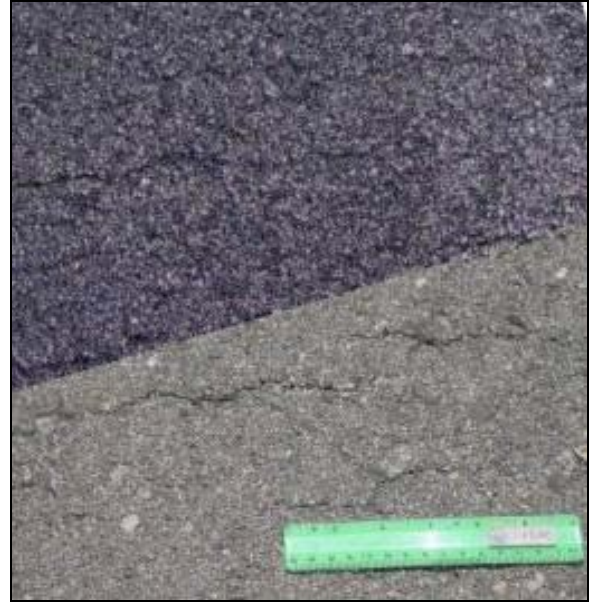
Figure 41. ‘Checking’ and hairline cracks.

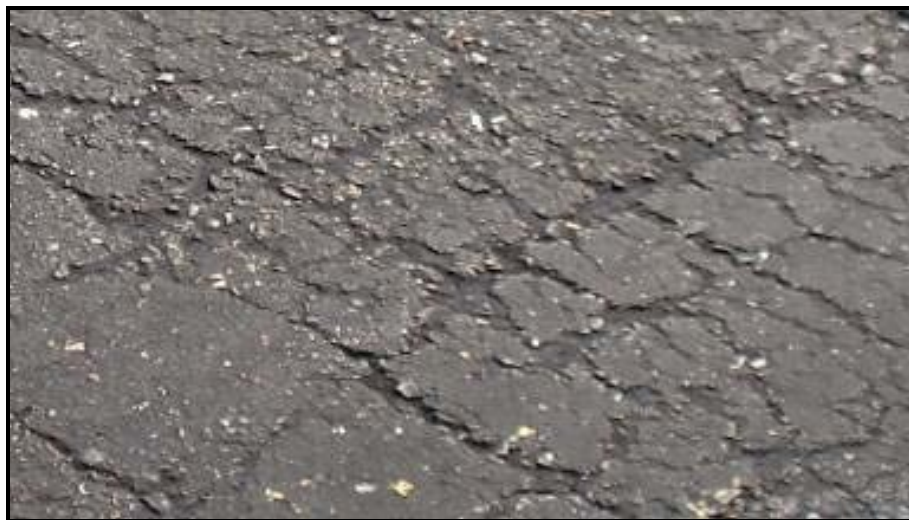
One of the first site visits for this evaluation was to the Boeing Test Facility in Glasgow, MT (see 2.2.1). During the visit it was clear from simple observation and anecdotal testimony from the airfield manager that GSB-78, the cutback version of GSB-88, had done an exceptional job in holding a very old asphalt pavement together well enough to remain in service long after such a pavement would be expected to have fully failed. Boeing airfield manager also noted that other types of materials and processes had been tried, but failed to provide similar benefits relative to reducing or stopping the deteriorating process as the GSB had. Figure 42 shows this older, badly deteriorating pavement at a Boeing facility is being held together with multiple GSB-78 applications.

Figure 42. Rebinding pavement at Boeing Facility, MT.

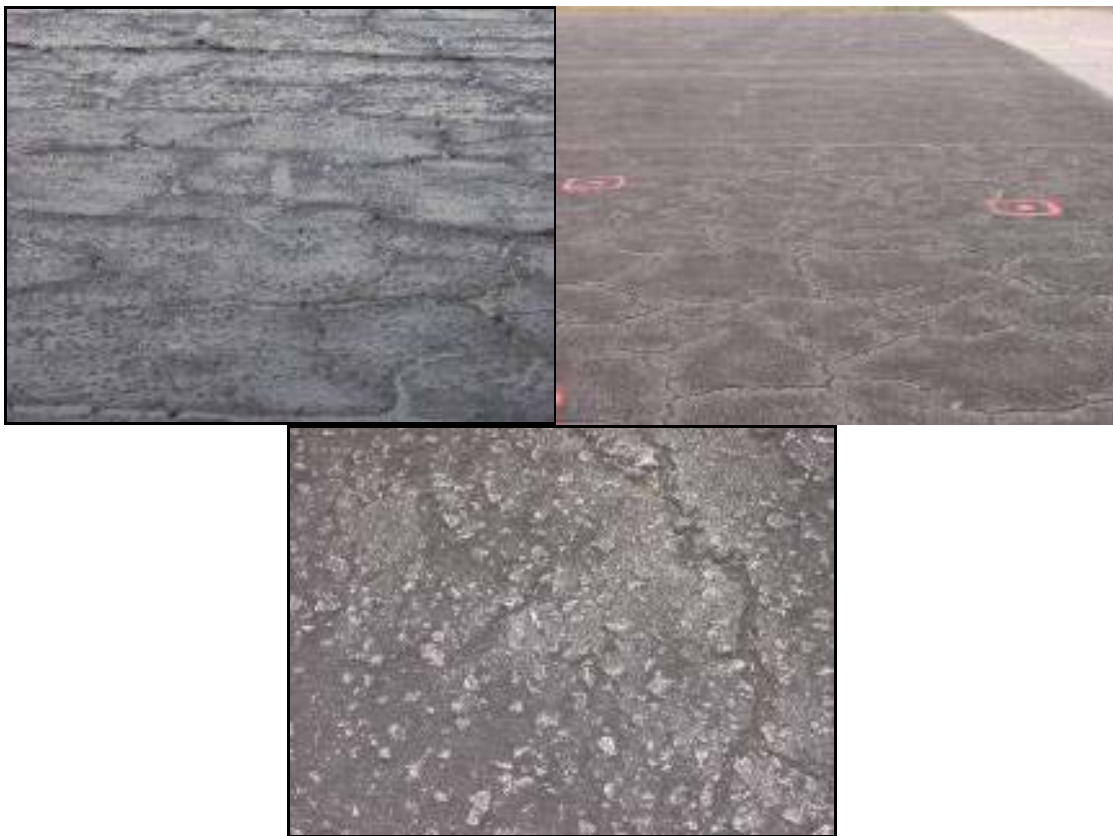
In addition, with the observations at Boeing in mind, Figure 43 shows heavy applications of GSB-88 at NAS Fallon, NV, Avon Park AFR, and PMRF Barking Sands, HI, helped to provide evidence that older pavements could benefit from similar applications. The Navy/DoD has numerous airfields and other asphalt pavements in inventory that are badly aged and at varying stages of reserved readiness. In many cases there is still some degree of use that could be of benefit to the Navy/DoD, and expensive rehabilitation is not a reasonable option. In the process of evaluating GSB-88 applications it has been observed that many marginal pavements that remain structurally sound, but badly weathered and cracked, could be brought to a higher state of readiness and maintained at that higher state for significantly longer period of time with repeat applications of GSB-88.

Figure 43. Rebinding pavement at Avon Park AFR, FL.
