TR-2363-SHR

EVALUATION OF A CORROSION CONTROL MATERIAL FOR ASPHALT PRESERVATION OF DOD AIRFIELD PAVEMENTS

Prepared by
G.D. Cline

May 2011

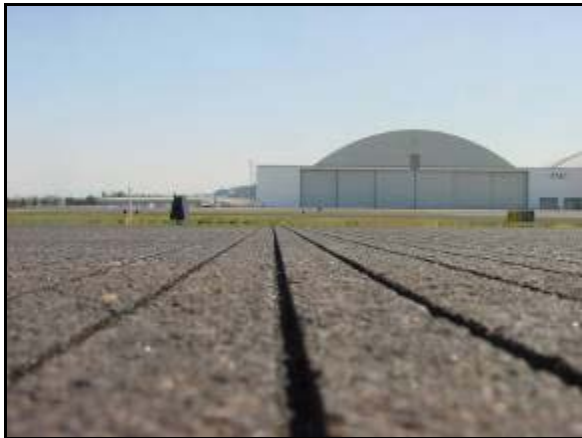
Figure 5. Groove remained sharp and clean.

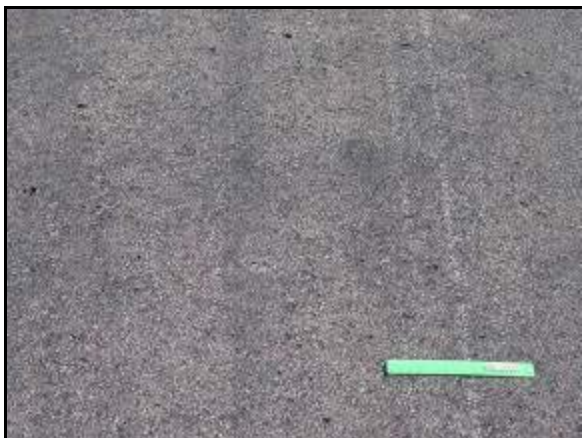
Portland-Mulino Airport services local general aviation. The Runway was paved in 1991 after which “pop-outs” or “holes” started appearing on the pavement surface. This was determined to be the result of a dry mix and soft aggregate dissolving. In 1993 GSB-88 was applied to attempt to mitigate the problem. The number of pop-outs or holes stopped increasing and was controlled for over seven years, at which time a second GSB-88 application was completed. This is shown in Figures 7 and 8. In addition, the Army’s evaluation in 2003 [3] indicated the pavement is in very good condition with an appearance that is relatively consistent throughout. The only noticeable defect was a short longitudinal construction joint crack. The most recent application was completed in 2005.

Figure 7. Holes from dissolving aggregate.

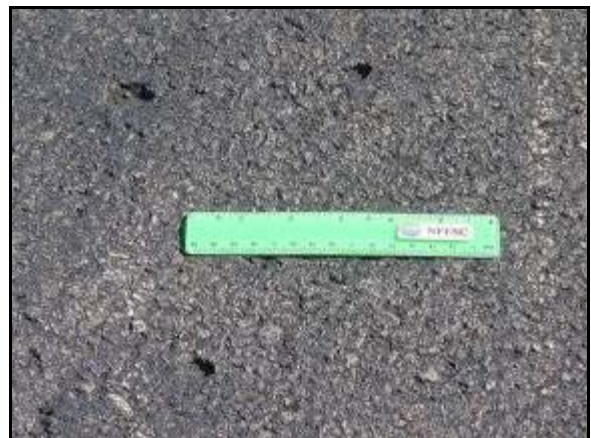
Figure 8. Holes sealed from water intrusion.

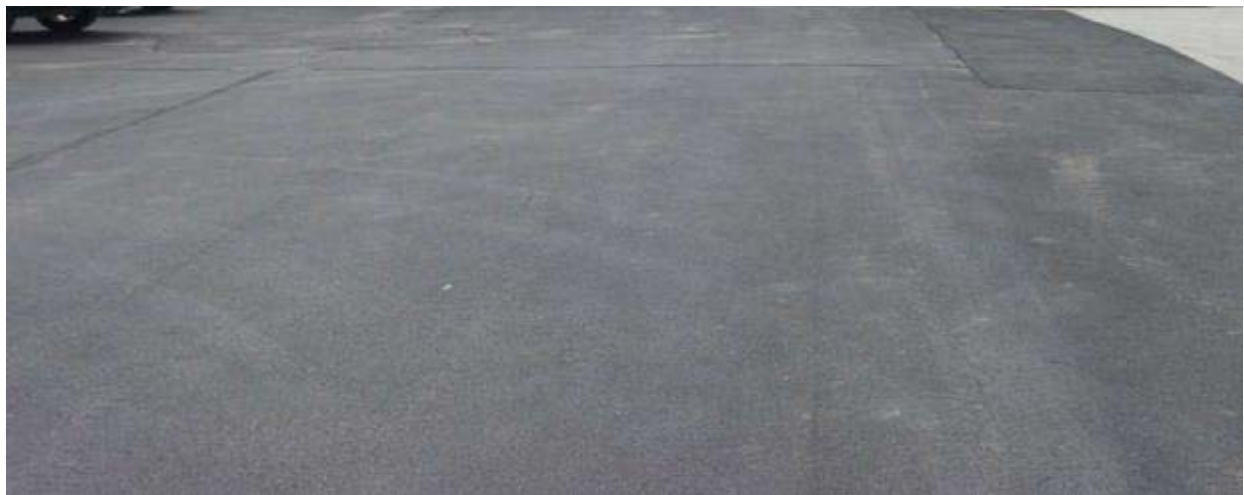
Figure 11. Pavement constructed in 1972 with GSB-78 applied every four years.

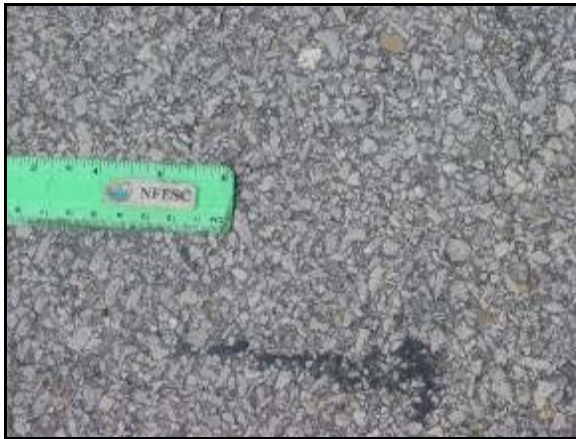
Figure 14. GSB-78 applied every 4–5 year.

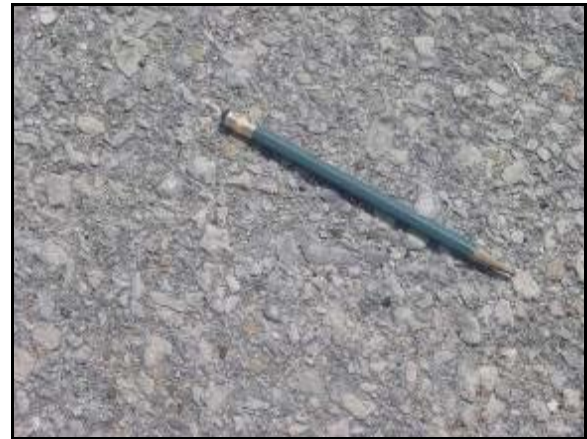
Figure 15. No treatment results in raveling.

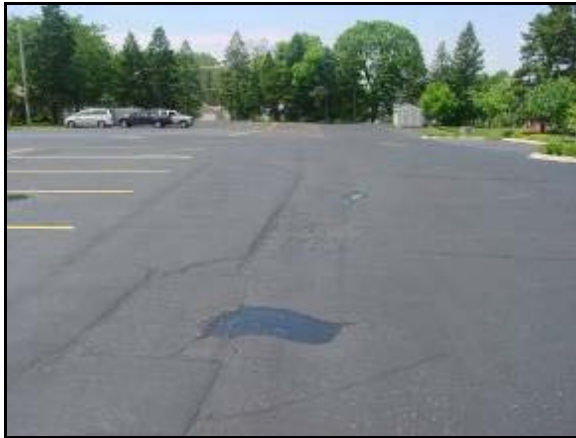
Figure 16. GSB will not stop structural distress.

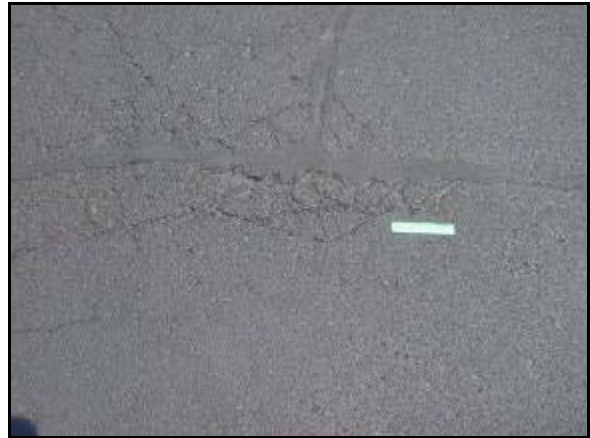
Figure 17. GSB seals and protects from water intrusion.

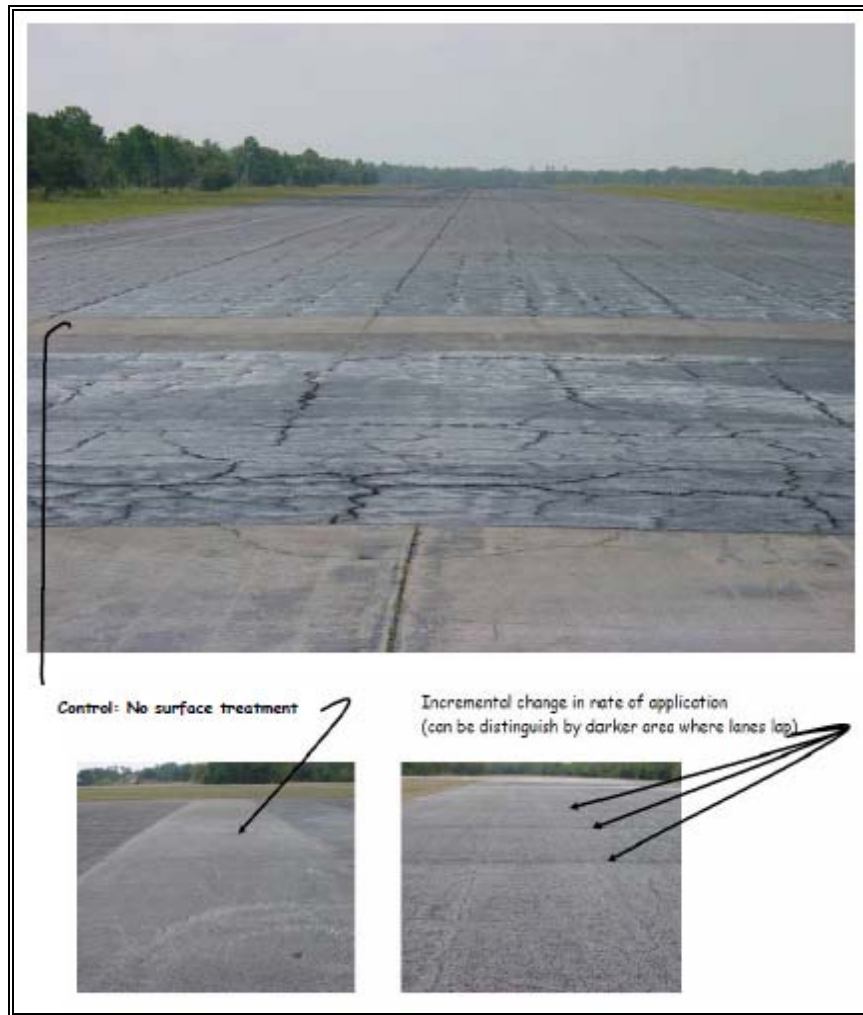
Avon Park AFR, FL provided another opportunity to observe various application rates of GSB-88 on badly deteriorated pavement of runway 14/32, which was reported to be in "Very Poor" condition, the heaviest being 0.22 gal sq/yd of 2:1 dilute. In the heavy application GSB-88 was observed to fill in the cracks, even with dirt and grass in some, while rebinding the surface aggregate. Since the pavement appeared to be structurally sound, but very badly affected by surface deterioration and oxidation, the heavier GSB-88 application appeared to sufficiently mitigate raveling and further surface deterioration as shown in Figure 32.

Figure 32. Runway 14/32, Avon Park AFR: application rate evaluation strips.

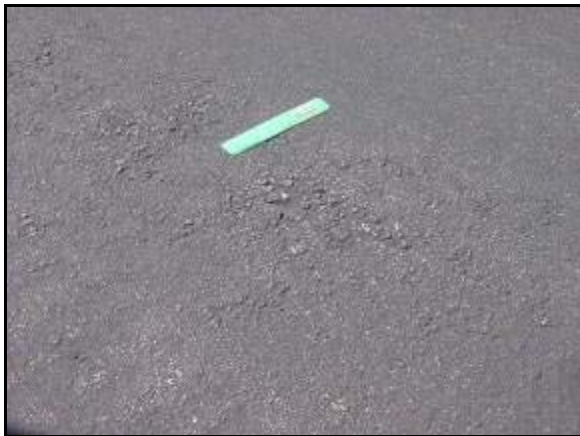
Asphalt pavement surface segregation can occur during paving if the asphalt is either too hot or too cool at the time of rolling, and the pavement binder and fines are segregated from the larger aggregate on the surface. Figure 33 is typical segregation. Figures 34 and 35 show other causes include equipment not clean or operating properly, poor practice of raking, paving too quickly or not fast enough, and others. Pavement segregation typically presents vulnerability in the pavement to potential early raveling because of its exposure of the inner pavement and lack of fines and binder. Segregation areas are commonly more absorbent of moisture into the pavement interior and generally collect additional water in their larger voids, accelerating surface oxidation. GSB-88 application to areas of segregation appears to fill those voids, rebind the overexposed aggregate, and seal the interior from moisture and ultraviolet penetration.

Figure 34. Segregation treated with GSB.

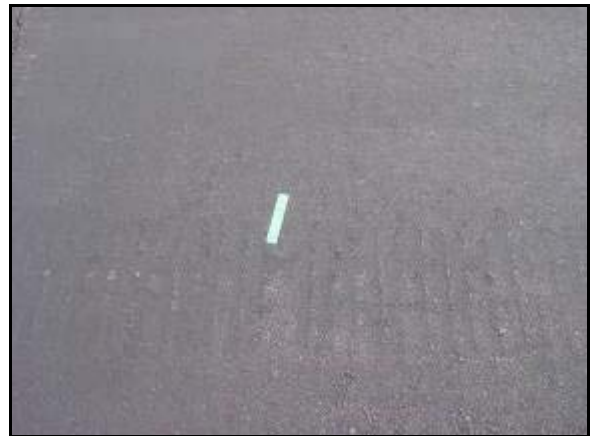
Figure 35. Pavement scars treated with GSB.
